THE HOME INSPECTION REPORT

21070401 - Client Last Name

123 Main Street, Sample City, NY 12345

07/04/2021 8:00 am - 11:00 am

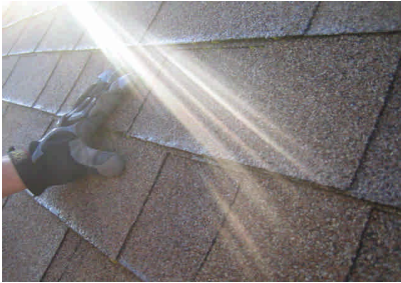
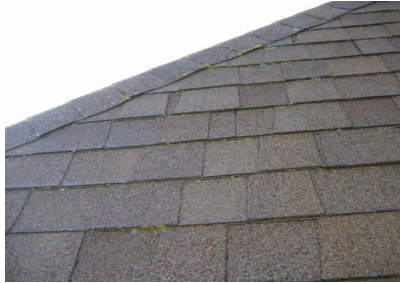
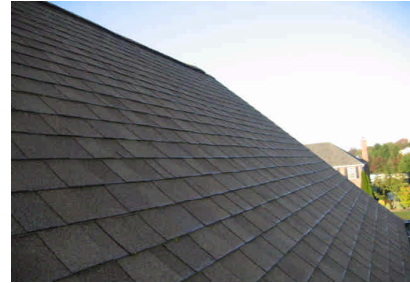
Method of Evaluation

I was unable to walk upon the roof surface because it was too slippery from dew. Inspection restriction. I moved my ladder around and inspected from the top of my ladder.

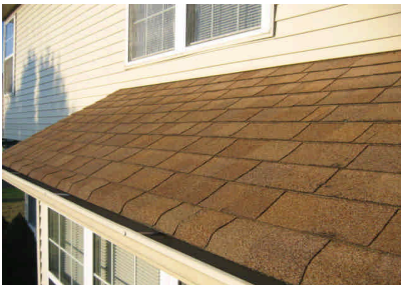
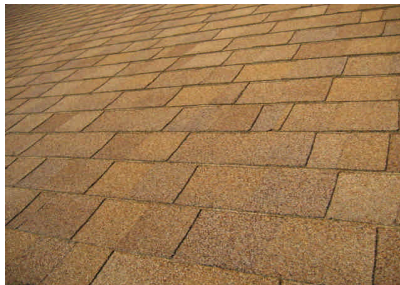
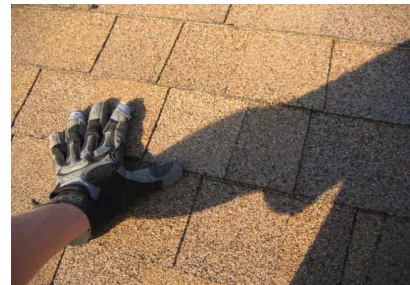
Condition

The asphalt shingle roof covering appears to be in good, functional condition. No major material defects. No major cracked, damaged, or missing shingles. Good. But this is not a guarantee against leaks in the future.

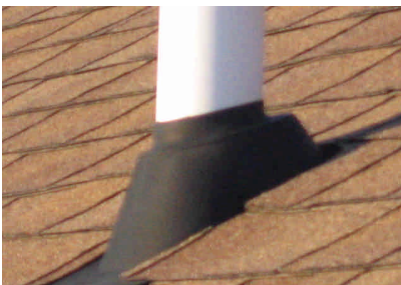
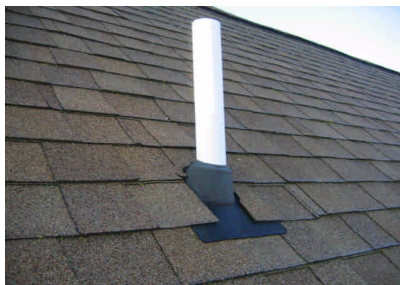
Flashings

The flashing around the vent stacks coming through the roof appear to be in good condition. Good.

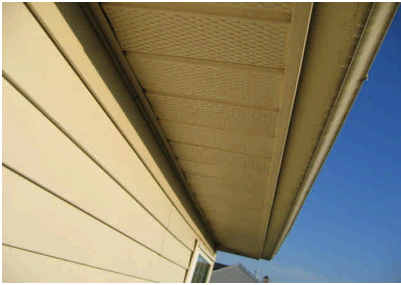
Ventilation

There are soffit vents and ridge vents installed to ventilate the attic space. Good.

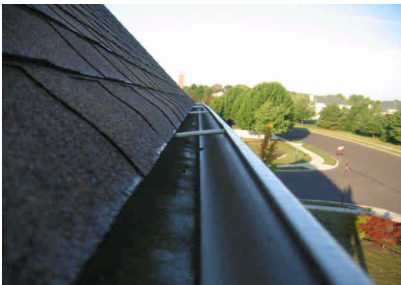
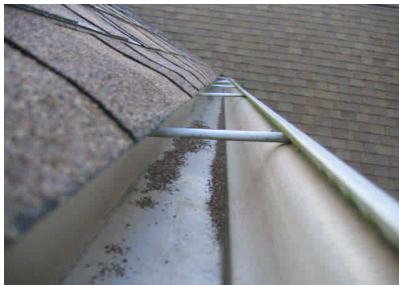
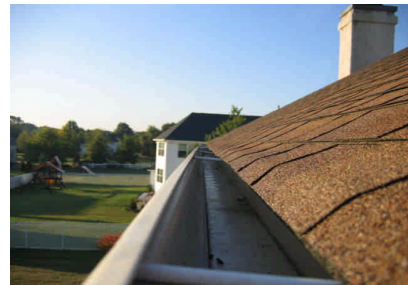
Gutters & Downspouts

The gutters and downspouts appear to be in functional condition. Good.

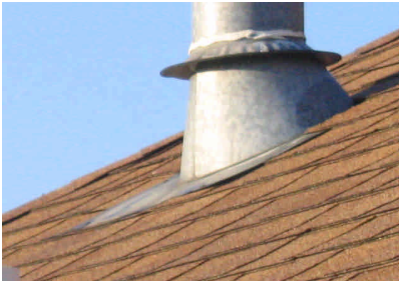
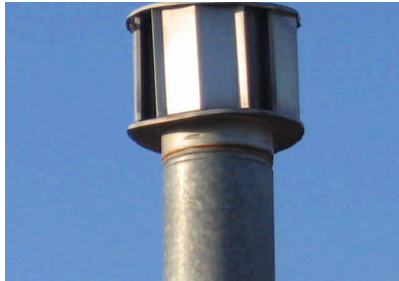
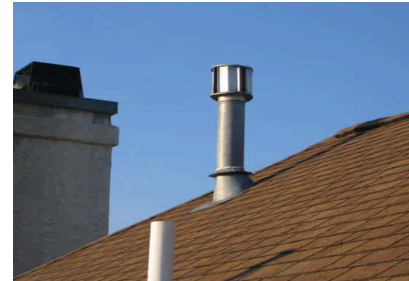
Gas-Venting Chimney Pipe Gas-Venting Metal Chimney Pipe

There is a chimney that is a pre-fabricated Type B gas chimney pipe, designed to carry away the exhaust of the gas-fired appliance(s) connected to it.

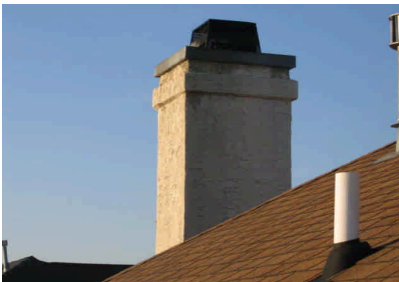
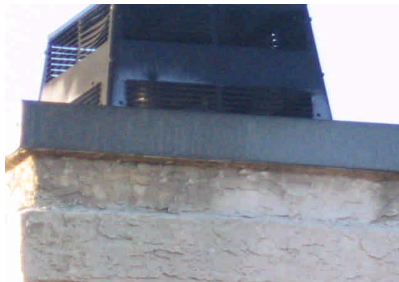
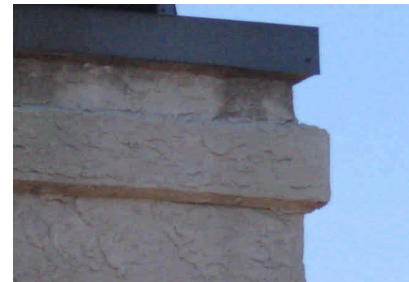
Chimney Flashings

A representative number of areas of chimney flashing were inspected. There is visible metal flashing installed around the chimney(s), where the chimneystack intersects the roof covering material.

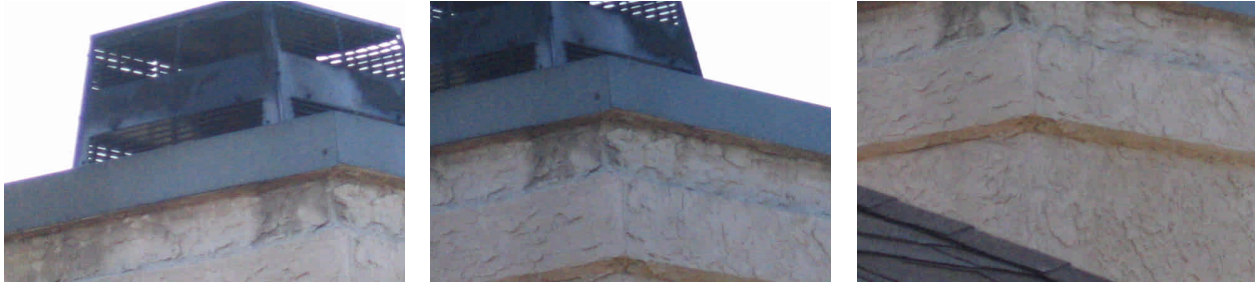
Observations

The chimney exterior sides appear to be in acceptable condition.

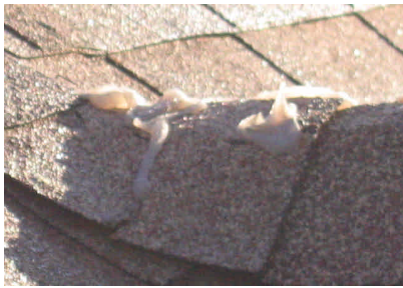
Chimney Flashings

The chimney shingle flashing where the stack meets the roof is heavily sealed. Sealant is not permanent.

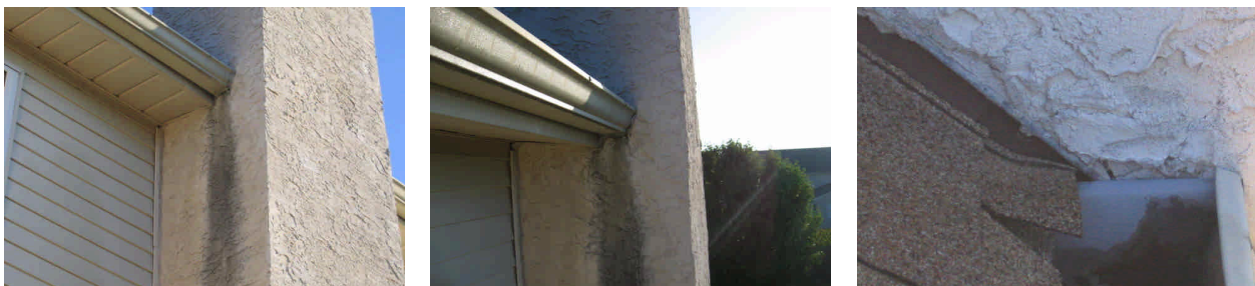
There is no kickout flashing used at the roof-to-wall intersection. Correction by a professional roofer is recommended. Located at the sides of the chimney stack. This may be allowing water draining off the roof to miss the gutter and drain behind the siding exterior covering. If not corrected, this could lead to water penetration and damage inside the wall. Kickouts also prevent water from streaking down the siding exterior covering and causing water stains. We recommend a kickout flashing - an angled piece of metal secured to the roof - to be installed near the bottom of the roof, to direct water into the gutter and away from this siding area.

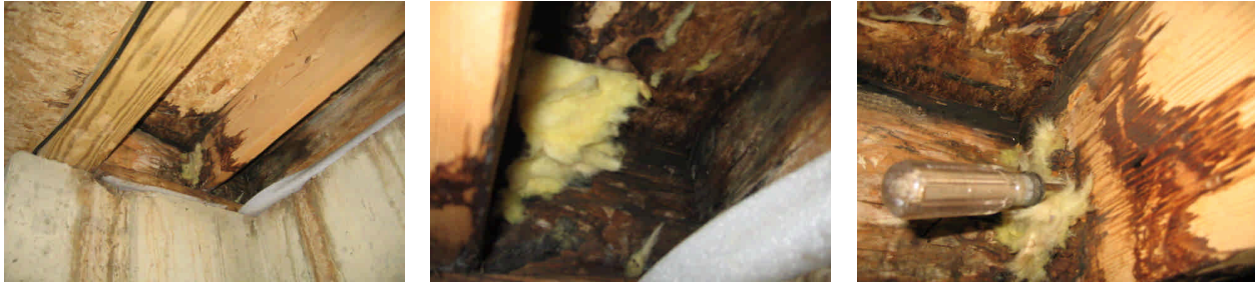
Major water damage visible from basement under the fireplace. Apparently caused by the missing flashing. Further evaluation of the structural integrity of the stack is recommended.

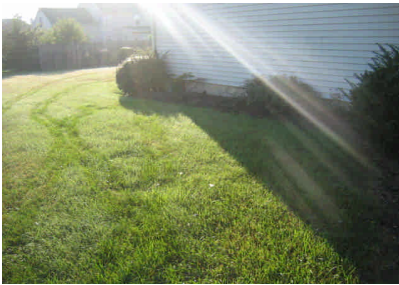
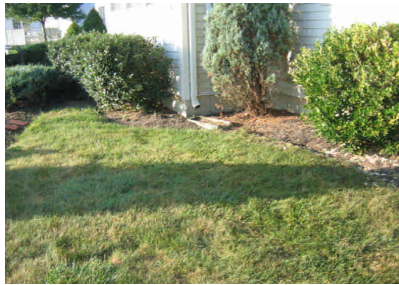
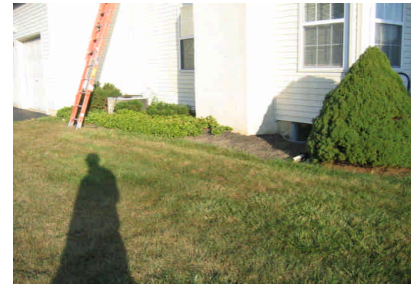
The general grading around the house foundation perimeter appears functional. Good. Ideally the grading should slope about 6 inches over the first 10 feet away from the house foundation. Monitoring during a rainstorm is recommended.

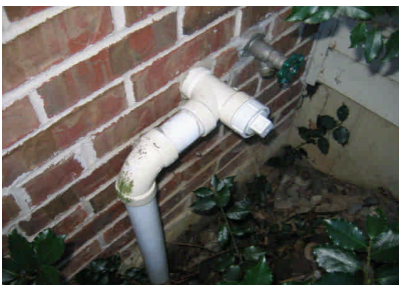
Sump Pump Pipe

There is a drainage system which includes a sump pump. Its discharge pipe is visible.

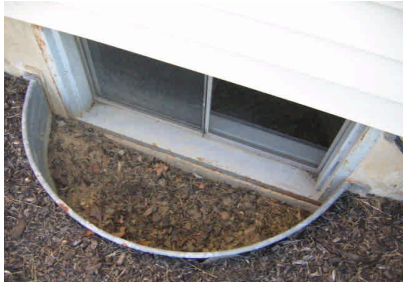
There's no window well cover. Consider installing one.

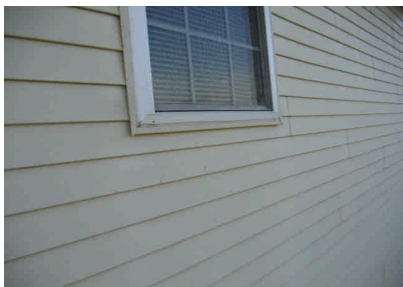
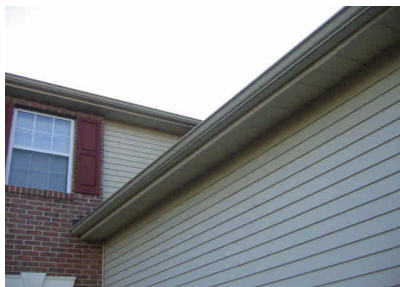
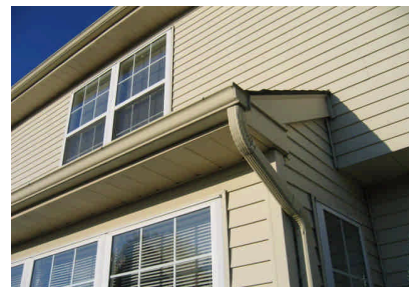
Vinyl

We moved around the house exterior several times, inspecting the vinyl siding on the exterior of the house. Checked for loose panels, missing panels, warped panels, cracked or damaged panels. This inspection does not include determining whether the siding has been installed to code, rule, or manufacturer's recommendations.

The vinyl siding appears functional. No major damage or deterioration was apparent. Recommend monitoring during a rain storm to see how the siding repels water. Be sure that the places where siding meets a different material is sealed or water-tight.

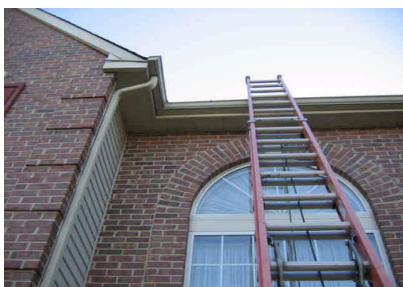
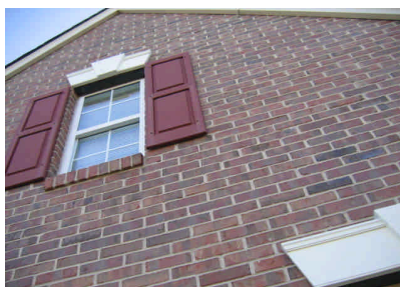
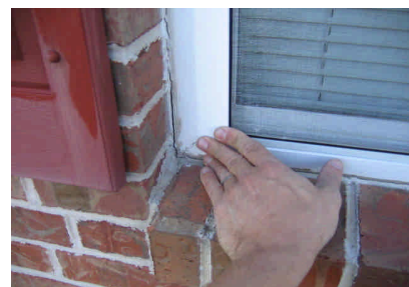
Brick

I moved around the structure exterior several times, inspecting the brick exterior of the house. Checked for loose bricks or mortar joints, missing pieces, damaged sections, deterioration, or failure. This inspection does not include determining whether the siding has been installed to code, rule, or manufacturer's recommendations.

The brick exterior covering appears functional. No major damage or deterioration apparent.

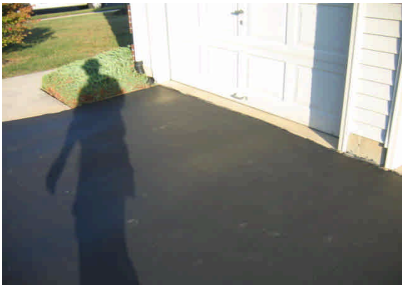
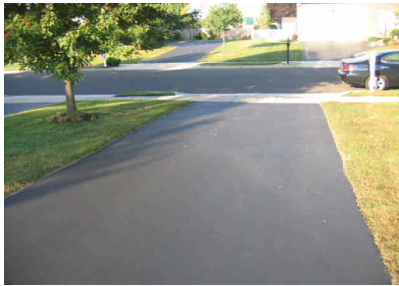
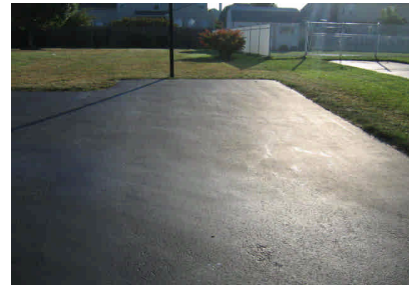
Exterior Components **Driveway or Parking**

The driveway appears functional.

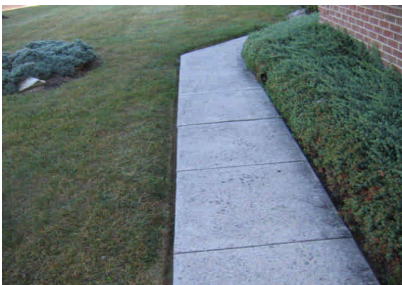
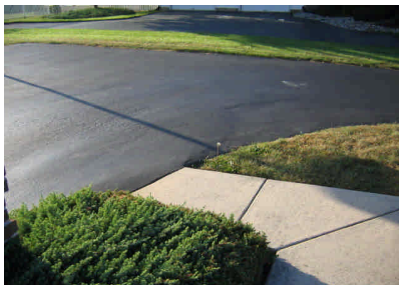
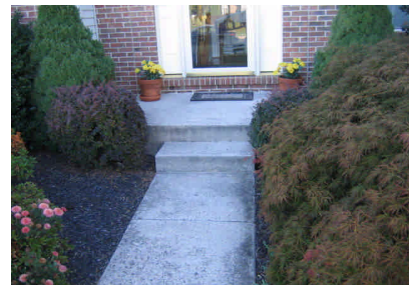
Walks

The walkways that lead to the entry doors appear functional. Good.

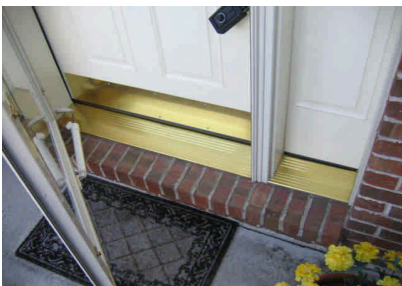
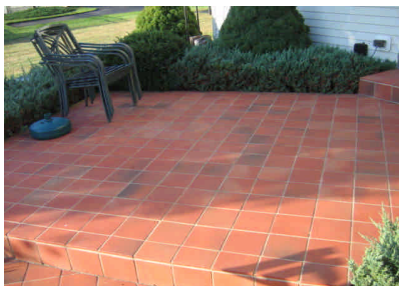
Steps & Handrails

The steps at the entry doors appear functional. Good.

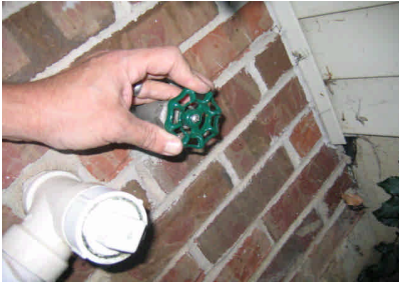
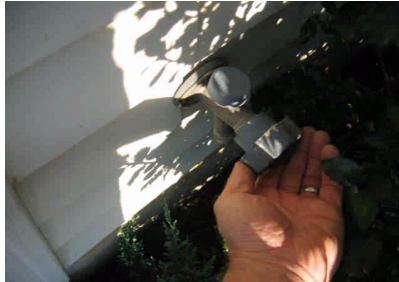
Exterior Water Faucets

The water faucet is frost-free. The faucet is designed so that it should not freeze and burst in the cold winter time. Good.

There is no running water at the faucet. Could be simply turned off. Recommend asking the seller. Located at the two faucets.

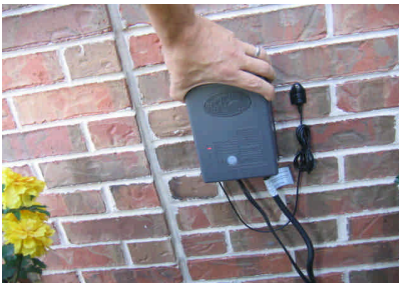
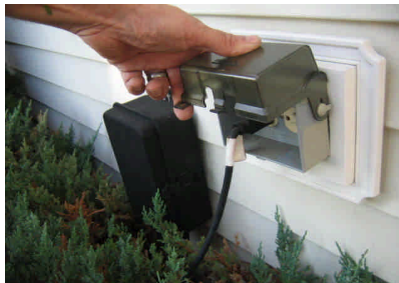
Receptacles & GFCIs

The exterior receptacles that were tested are functional and include ground-fault protection. Good.

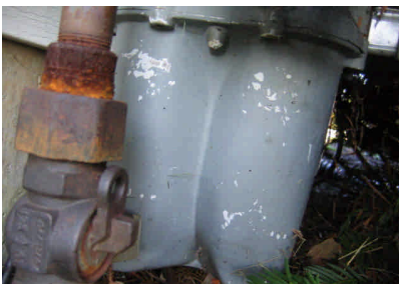
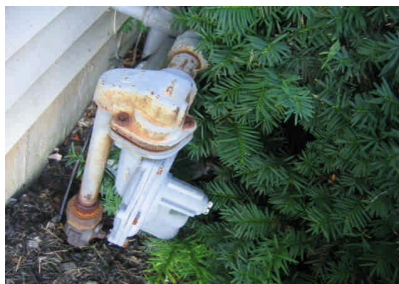
Public Gas Meter

The main gas shut-off valve is located near the gas meter at the side of the house.

The gas meter has some surface rust on it.

Sealant needed around the gas line where it enters the house - minor.

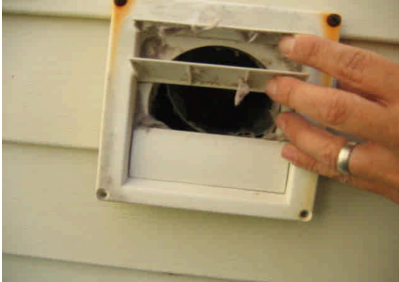
Dryer Vent Hood

The dryer exhaust hood appears functional. No damage to hood or damper. No major lint build-up. We recommend inspecting and cleaning the dryer's exhaust pipe every year.

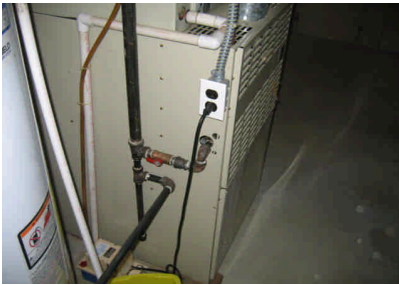
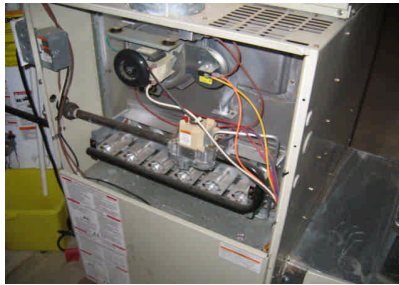
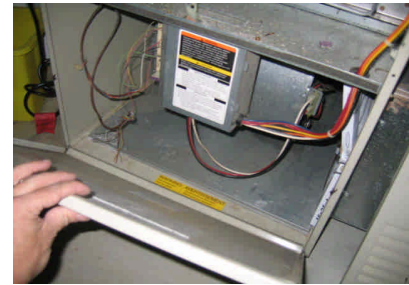
The heating system was inspected by using normal operating controls. We inspected for material defects. We are not HVAC professionals. Feel free to ask the seller to have the heating system inspected and certified by a HVAC professional prior to closing. Annual inspection and service is needed.

Recommend having the heating system inspected, cleaned, and serviced by an HVAC professional prior to closing.

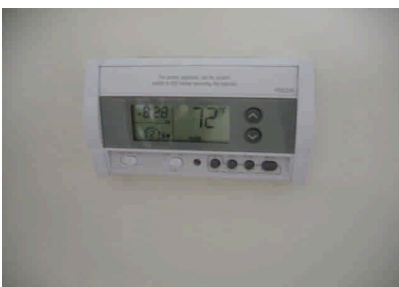
Thermostat

The thermostat is functional.

There is a thermostat located on first floor.

The thermostat appears to be electronic and programmable. Nice. Ask seller for booklet on the thermostat.

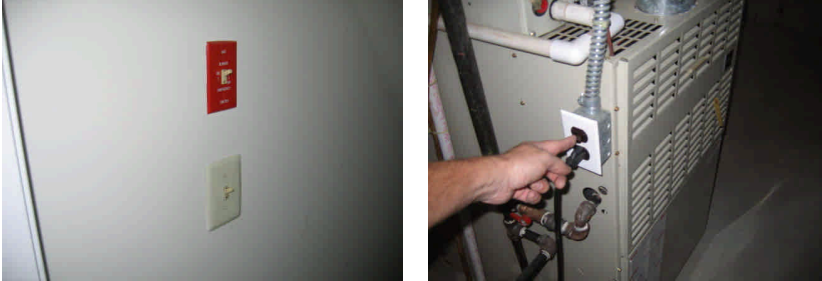
Electric shut-off switch

There is an electrical shut-off switch located on the side of the heating system.

There is an emergency shut-off switch located at the basement stairs.

The electrical shut-off switch functioned. Good. I would use this switch when inspecting the air filter.

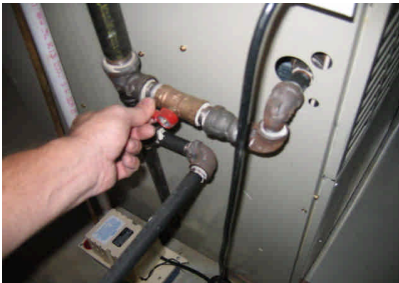
Gas shut-off valve

There is a gas shut-off valve near the heating system. Good.

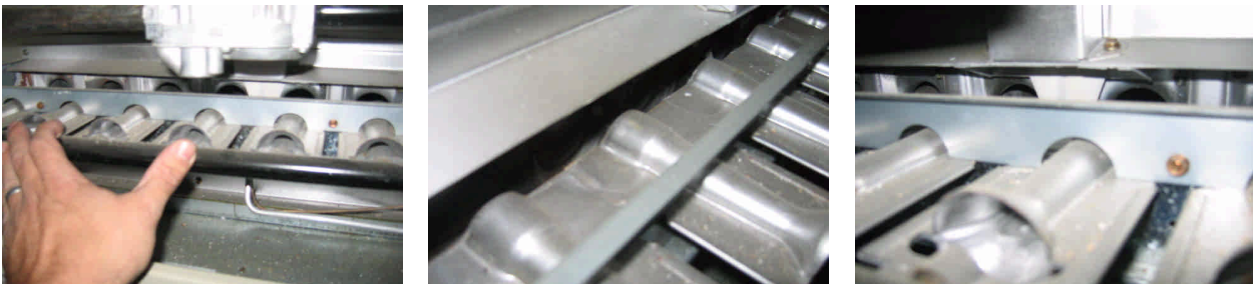
Gas Burners

The gas burners of the heating system appear relatively clean. Good.

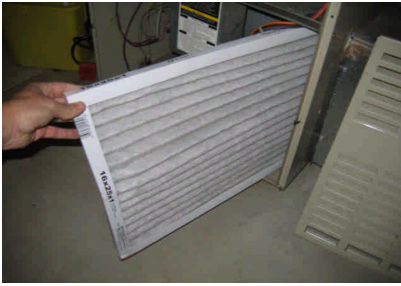
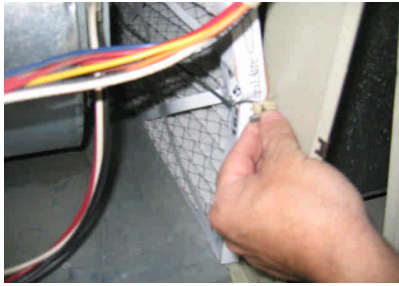
Air filter

The air filter is disposable and clean. Good. Check the filter every 30 days. Replace when necessary.

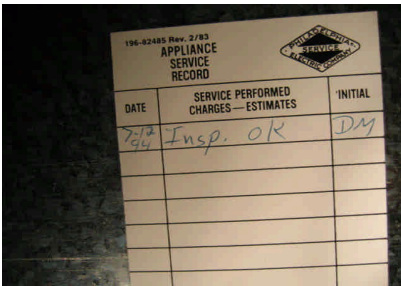
Service record

The last time the heating system was service has been recorded. Dated in 1994. The heating system should be serviced every year.

The heating system should be serviced every year by a HVAC professional technician. Make sure they record the service on a tag near the heating system, including date, name of technician, and what was done.

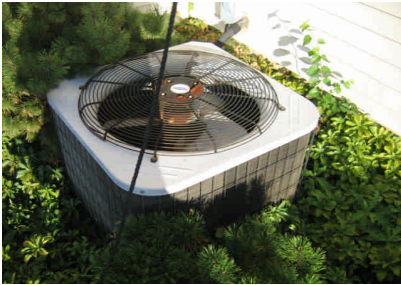
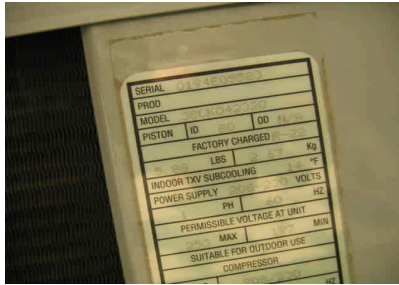
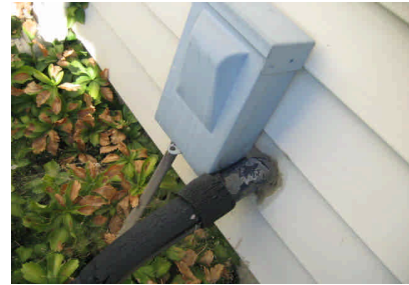
Exterior Condenser Unit(s) For Your Information

The air conditioner system was inspected. We only use only normal operating controls, such as the thermostat and electric switches. We are not HVAC professionals. Feel free to hire one prior to closing.

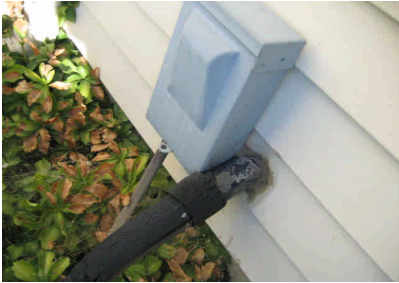
Electrical Disconnect

There is an electrical disconnect near the exterior condenser unit.

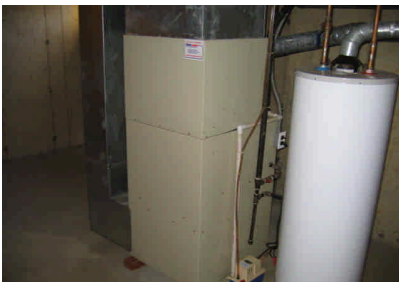
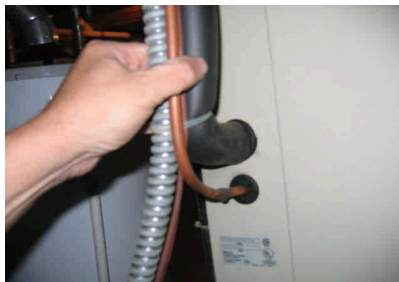
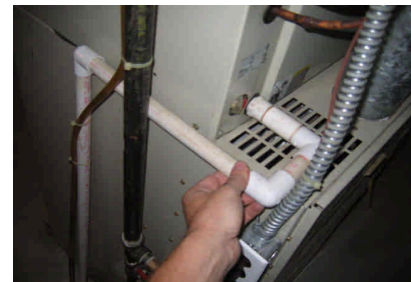
Interior Evaporator Unit(s) For Your Information

We use normal operating controls to inspect the interior evaporator coil unit. We use the thermostat. We inspect the condensate drainage. Check the insulation around the refrigerant line. Check for major rust and corrosion on the unit. Check for condensate water leakage and damage. Inspect the air filter.

The thermostat for the cooling is the same as the heater's thermostat.
The electric shut-off switch is the same as the heater's.
The air filter is the same as the heater's filter.

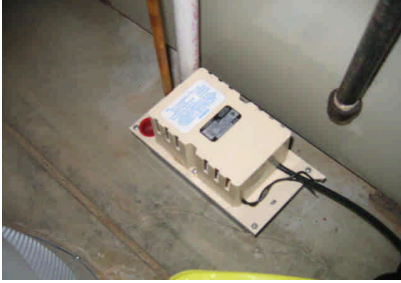
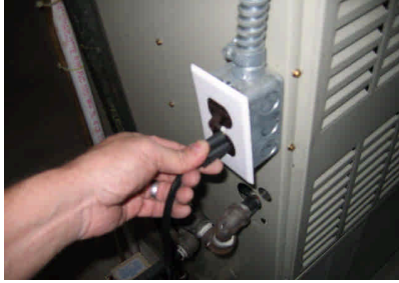
Service Record

There is no visible recent-service tag on the air conditioning system. Possibly indicating delayed maintenance. Recommend having the system cleaned, inspected, and serviced by an HVAC professional.

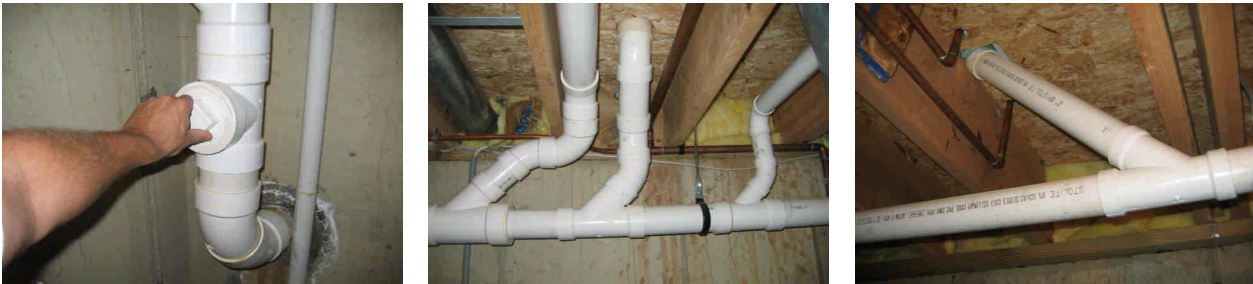
Drain Waste Vent Pipes Type of Material

Visible portions of the drainpipes are of PVC, poly vinyl chloride. Very commonly used material.

Not all of the drain pipes were readily visible. Much of the pipes are inside the walls.

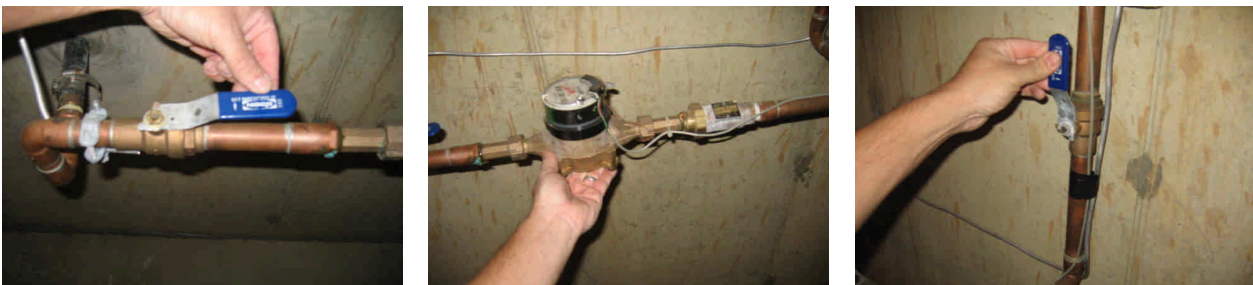
Public Water Supply Main Water Shut-off Valve

The main water shut-off valve is located in the basement.

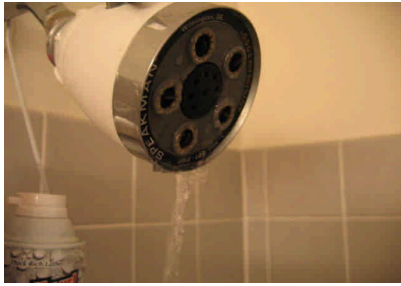
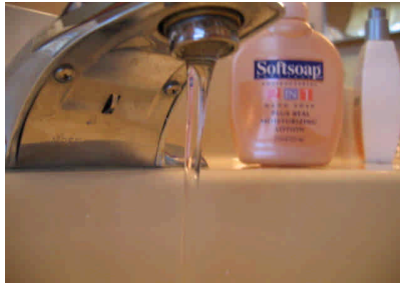
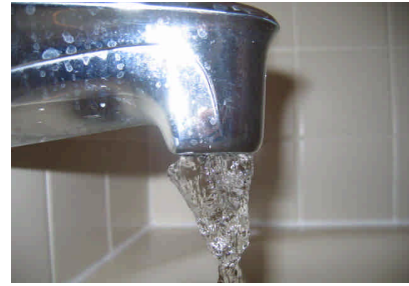
There is a noticeable low flow of hot water at the bathroom fixtures. Only one fixture can run hot water at a time. Further evaluation by a plumber is recommended.

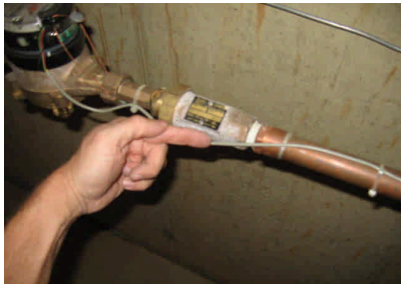
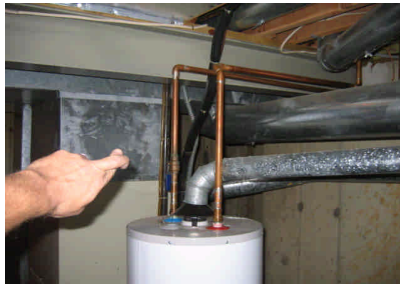
There is a pressure regulator installed on the main water supply line coming into the house. This regulator has a valve that prevents water from pushing back out to the street, and makes the plumbing system a closed water system. When the water heater makes hot water, the water in the system expands. The expansion of the warm water increases the pressure on the homes water pipes. An expansion tank installed on the water line would absorb the extra pressure. There isn't one installed through. The relief valve on the water tank may start to drip, because of the lack of an expansion tank. The action of the expansion tank also reduces knocking of the pipes, and wear and tear on the faucets and shut-off valves in the home. We recommend installing an expansion tank.

The relief valve on the hot water tank is actively leaking water into a bucket.

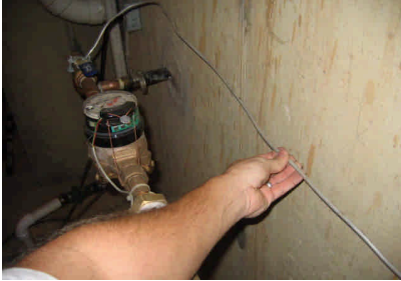
Jumper Cable at Meter

There is a jumper cable installed over the water meter - Good.

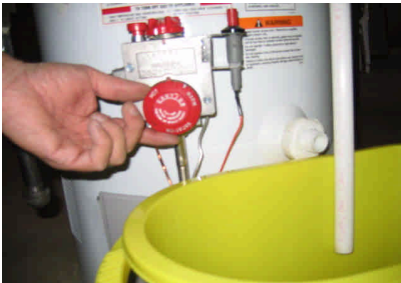
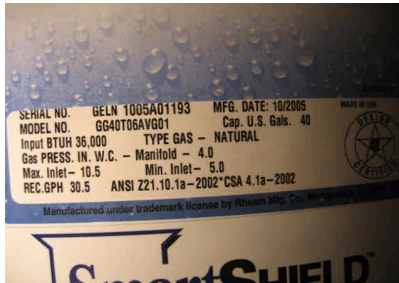
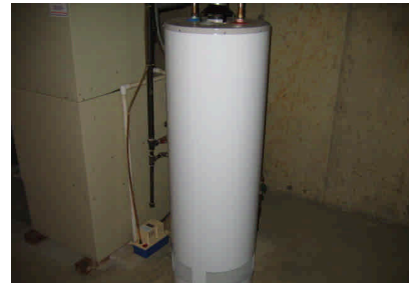
There are a wide variety of residential water heaters. They can be expected to last at least as long as their warranty, or from five to eight years, but they will generally last longer. However, few of them last longer than fifteen or twenty years and many eventually leak.

The water heater is 40 gallons in size.

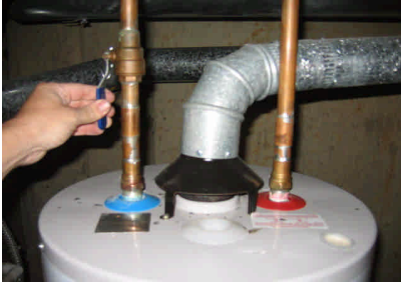
Water Shut-Off Valve & Connectors

The water shut-off valve to the water heater tank is installed. Not leaking. This valve turns off the cold water supply to the tank. Good.

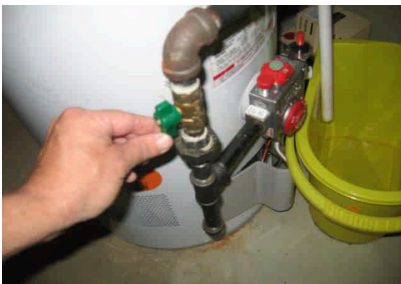
Gas Shut-Off Valve

The gas shut-off valve at the water heater is installed within reach of the tank. This valve turns off the gas supply to the tank. Good.

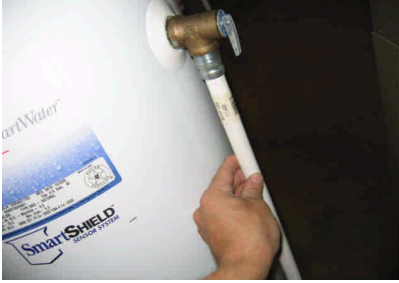
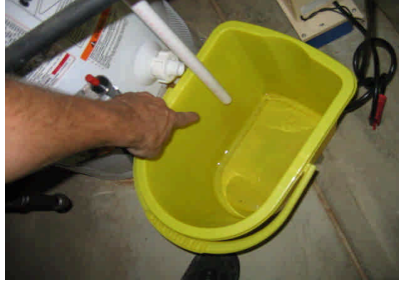
Relief Valve & Discharge Pipe

The pressure relief valve on the water heater is dripping water - leaking. Indication of a failure in the relief valve itself, or a pressure/temperature problem with the water heater tank.

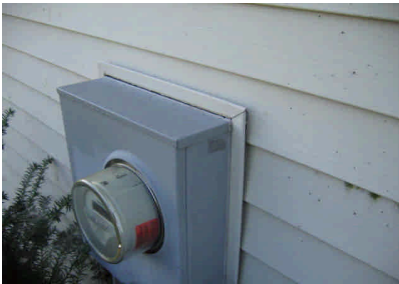
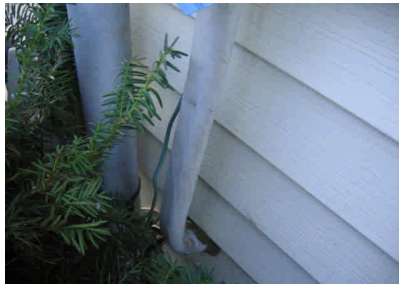
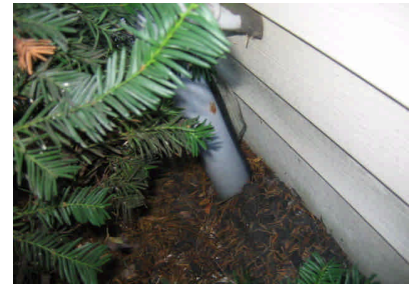
There is one electric meter.

The meter is located on the left-side of the house.

The meter box exterior appears functional. No major rust or damage. Not loose. Good.

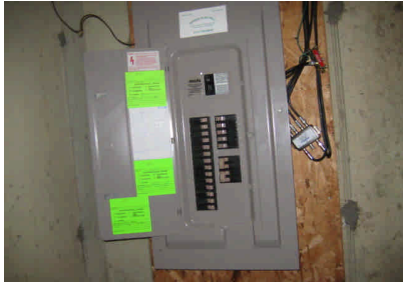
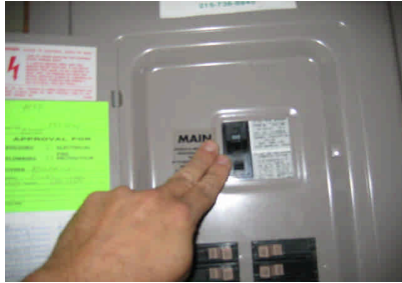
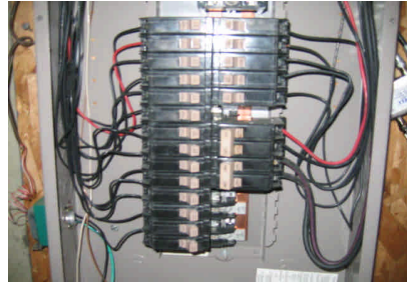
The main panel is located in the basement.

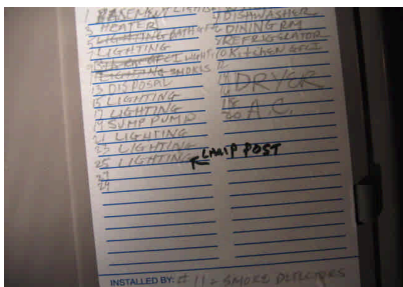
All of the breakers seem to be labeled. Good.

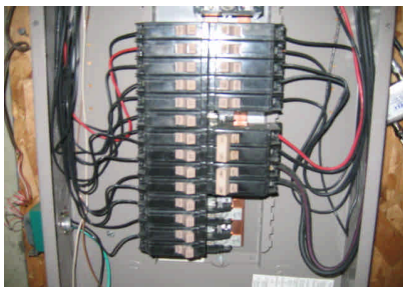
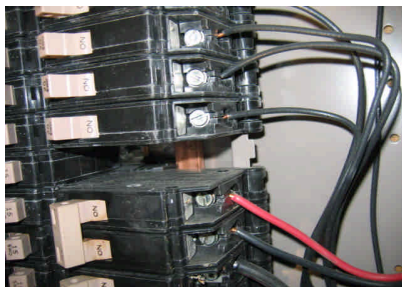
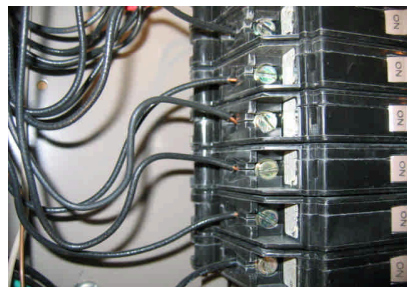
There is apparently open room for additional breakers and circuits.

The system does not include arc-fault circuit interrupters, which effective January 1st, 2002, are mandated by the national electrical code to protect 15 and 20 amp branch circuits serving bedrooms in new construction. This is not a new home, so simply consider the benefit of installing them.

AFCI breakers are required to be installed on all the bedroom circuits. These safety devices are intended to detect the kinds of electrical arcs that can cause fires. An AFCI breaker is designed to trip when it detects a dangerous arc, either in the house wiring or in a defective extension cord or appliance.

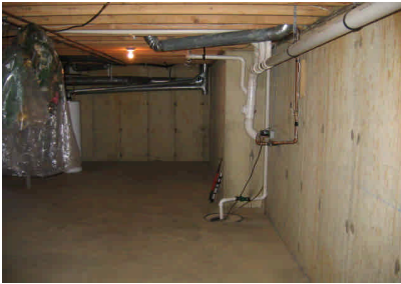
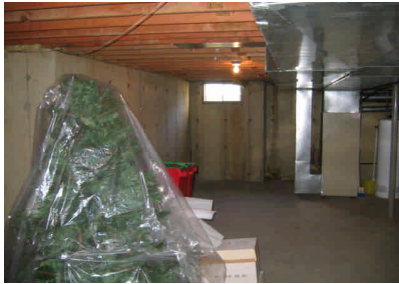
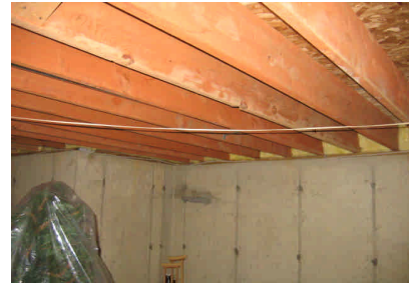
This residence has a basement. We try to enter and inspect all accessible areas, looking for any evidence of structural material defects. We look for cracks, but those that are less than ¼" and which do not exhibit any vertical or horizontal displacement are generally not regarded as being material structural defects. We look for signs of water penetration too, but please consult the seller's disclosure.

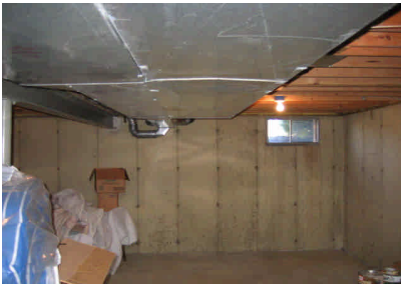
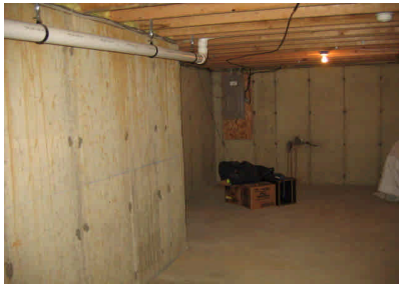
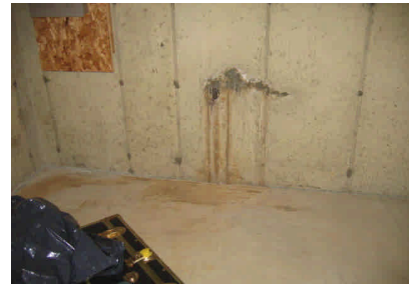
We do all we can to see everything in the unfinished basement. There are restrictions to the inspection though. Including but not limited to the electrical wires, pipes, storage, ductwork, insulation, floor coverings, etc.

There is insulation at the band or rim joint areas, which is above the foundation wall, at the outer perimeter of the floor system. This insulation restricts the visual inspection of those areas considerably.

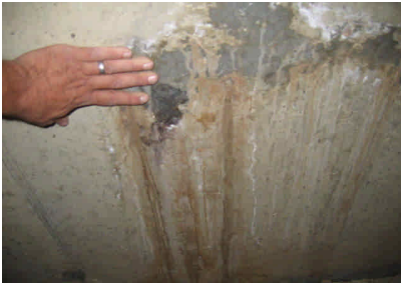
There are indications of previous ground water penetration through a foundation crack. Water marks. It has leaked in the past and may likely leak again in the future. Ask seller when the crack leaked in the past. Located at the left-side wall, near electrical panel.

Foundation cracks can be repaired using an epoxy ejection method. Epoxy ejection repairs are considered affordable and effective. Epoxy ejections make a bond between the cracked sections of the foundation that is actually stronger than the concrete itself. Further evaluation and correction to the foundation crack(s) by a professional (one familiar with epoxy injection repairs) is recommended.

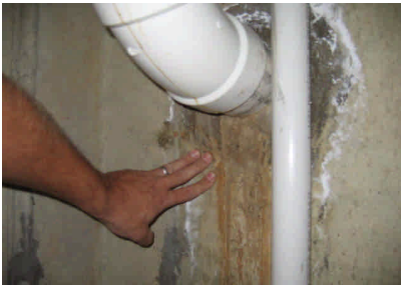
There are dry water marks around the sewer line. Located on the front wall.

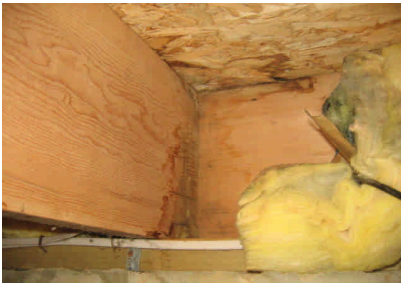
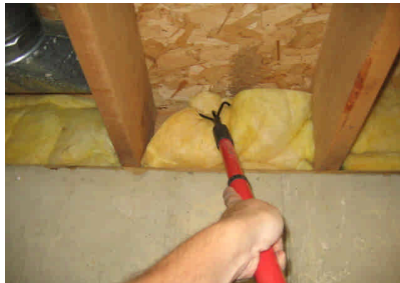
There are water stains in areas on the floor under the rear exterior door. Possible water problems in the past. Ask seller.

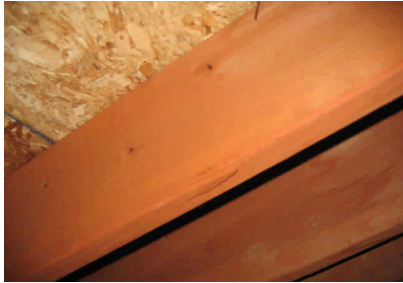
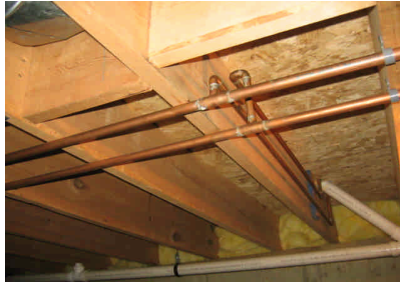
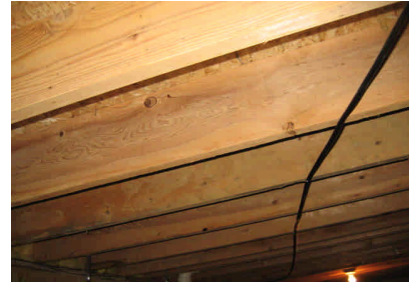
The floor joists are made of dimensional wood lumber - 2x10s.

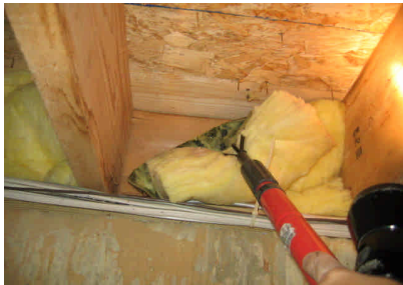
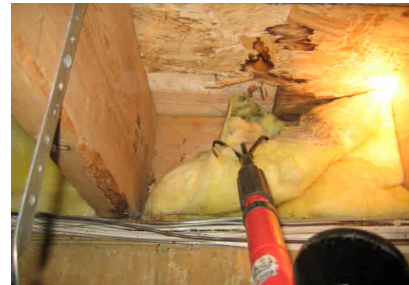
There have been structural repairs to floor under front entry door. Ask seller about prior repairs and possible water penetration problems.

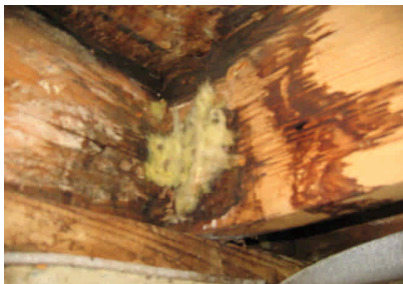
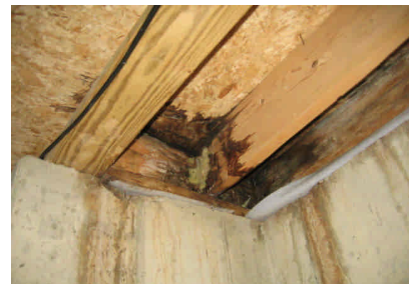
There is major water damage at floor components. Above the foundation wall. Located under the fireplace.

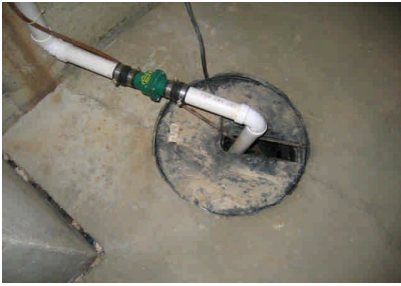
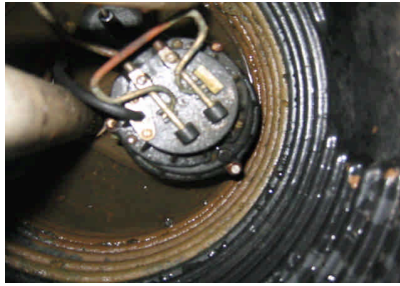
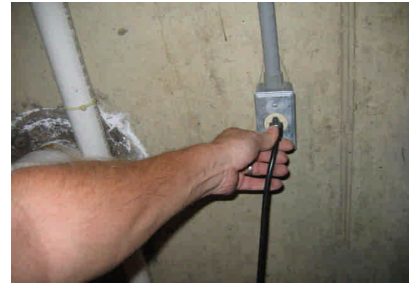
There is a sump pump being used. Recommend asking the seller why a sump pump has been installed. Has there been water penetration problems that required the pump to be installed?

There is water in the sump pit.

The pump turned on.

Discharged water.

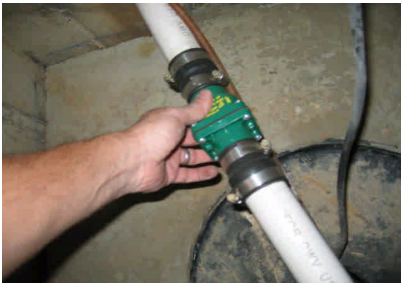
A check-valve is installed on the sump pump's discharge pipe. Good.

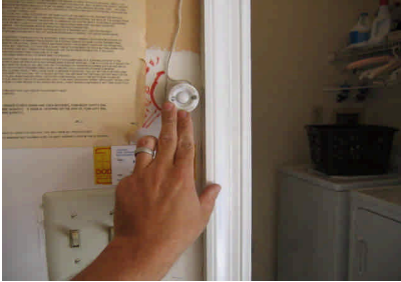
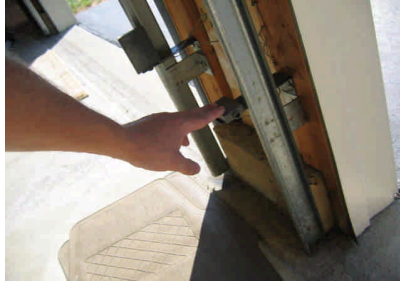
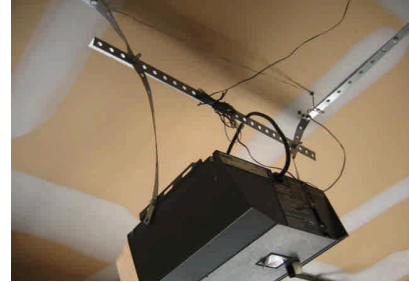
Each garage door opener is functional. With functional infra-red sensors.

The infra red auto-reversing sensor mechanisms are functional but located higher than the recommended six inches above grade.

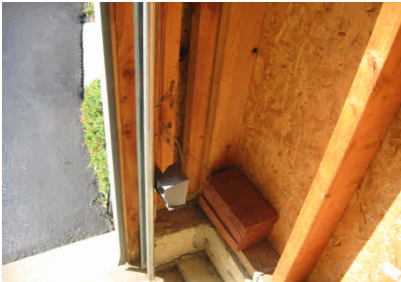
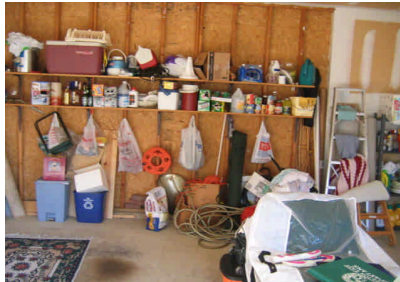
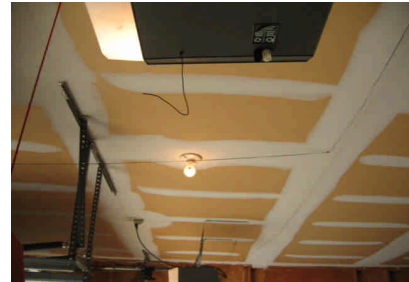
The finished walls and ceiling appear in good condition.

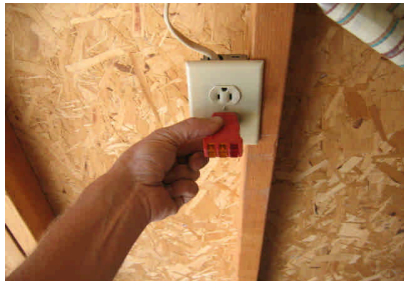
The receptacle in the garage (left-side wall) should be upgraded to have GFCI or ground-fault protection, which is required by current standards and is an important safety feature.

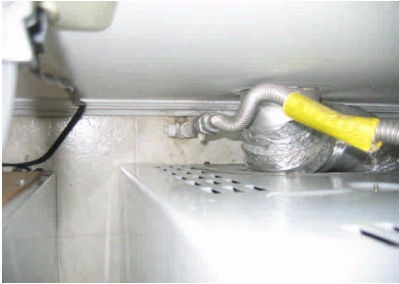
The laundry dryer vent pipe seems functional.

Faulty dryer vents have been responsible for thousands of fires, hundreds of injuries, and even deaths. The best vents are a smooth-walled metal type that travels a short distance; all other types should be regarded as suspect, and should be inspected bi-annually to ensure that they do not contain trapped lint or moisture.

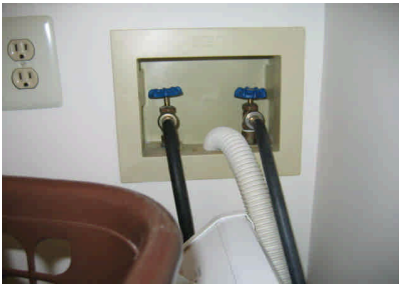
Rubber hoses should be replaced with more reliable ones - pressure-tested hoses. Such as stainless-steel, braided mesh hoses.

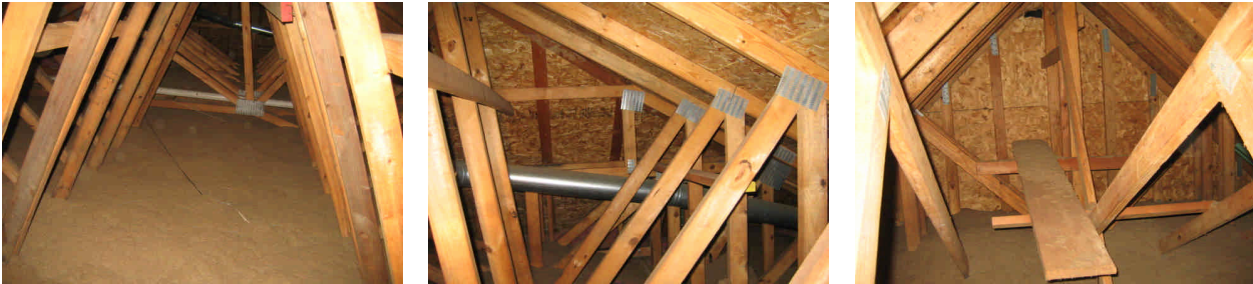
We inspected the attic by entering it. But there is no flooring, and the insulation is covering the joists. I am unable to safely move all around the attic space completely. Inspection restrictions.

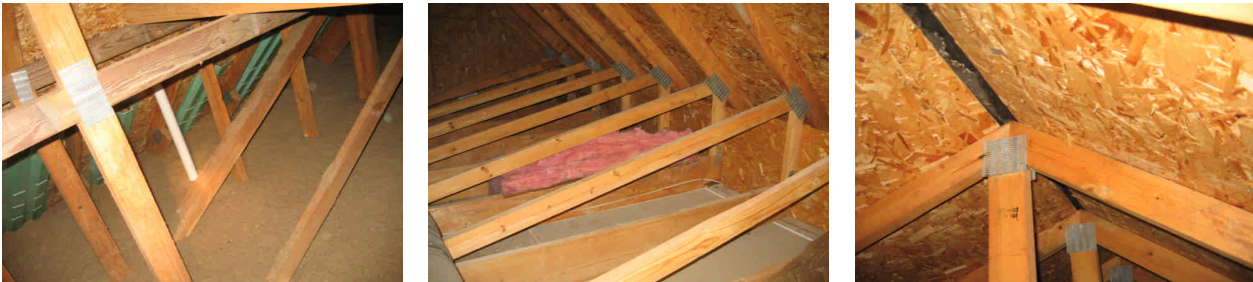
The roof framing consists of an engineered truss system, comprised of components called chords, webs, and struts that are connected by wood or metal gussets nailed or glued in place. Each component of the truss is designed for a specific purpose, and cannot be removed or modified without compromising the integrity of the entire truss. The lowest component, which is called the chord and to which the ceiling is attached, can move by thermal expansion and contraction, and may cause common drywall pops and drywall cracks.

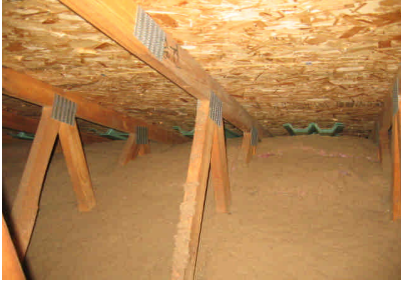
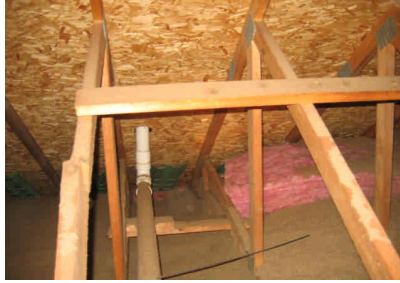
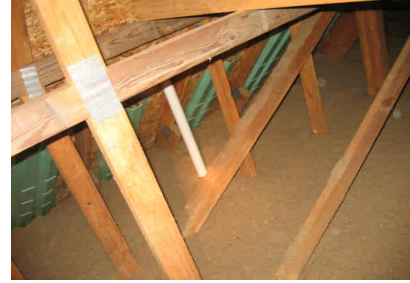
Type of Insulation

Cellulose insulation is installed. Cellulose building thermal insulation is a recycled product made from recovered newsprint, the largest single component of the residential waste stream in most communities.

Appears well insulated.

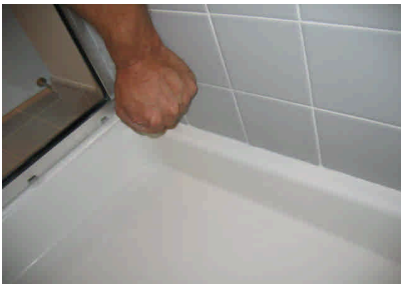
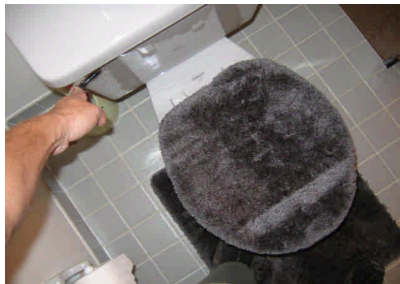
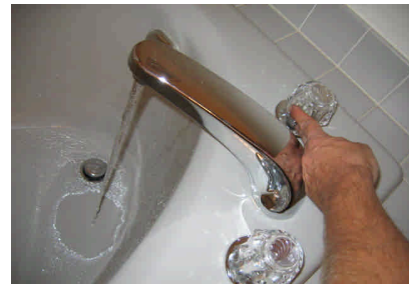
Master Bathroom **No Recommended Service**

We inspected the bathroom, and found no major defects. Toilet flushed a couple times. Running water at the sink. Sink drained. The tub/shower functional. No active leaks.

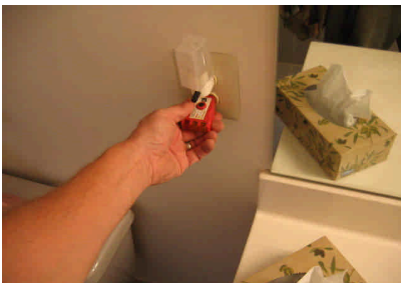
Master Bath Receptacles

The receptacles are testing functional and include ground-fault protection (GFCI). Good.

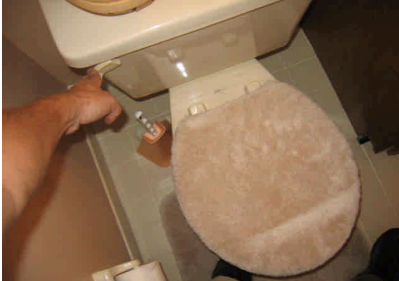
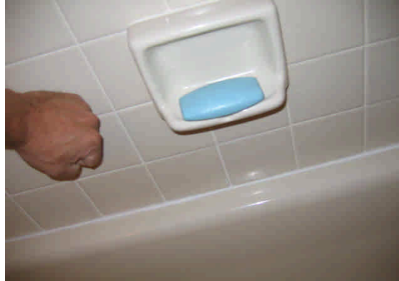
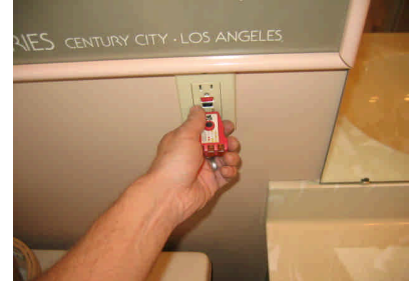
2nd Floor Full Bathroom **No Recommended Service**

We inspected the bathroom, and found no major defects. Toilet flushed a couple times. Running water at the sink. Sink drained. The tub/shower functional. No active leaks.

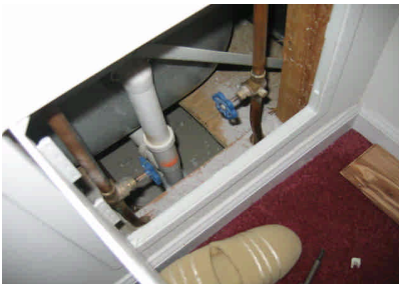
Access panel

There is an access panel for the tub. It was opened. No water leaks. Good.

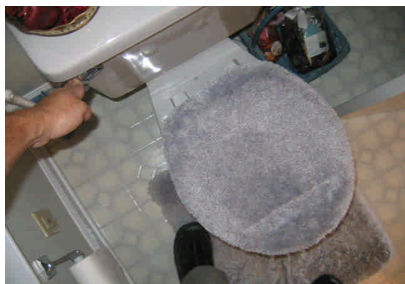
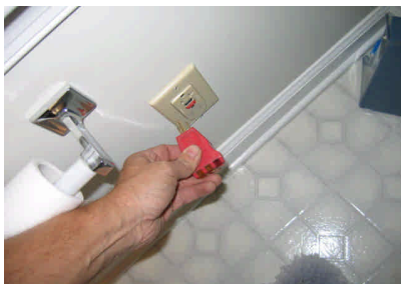
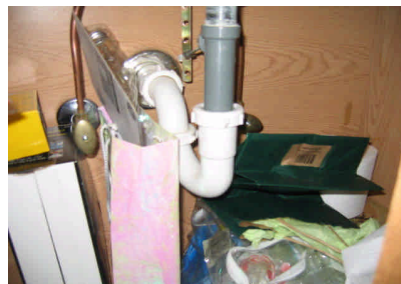
First Floor Half Bathroom **No Recommended Service**

We inspected the 1/2 bathroom, and found no major defects. Running water at the sink. Toilet flushed a couple times. Sink drained. No active leaks.

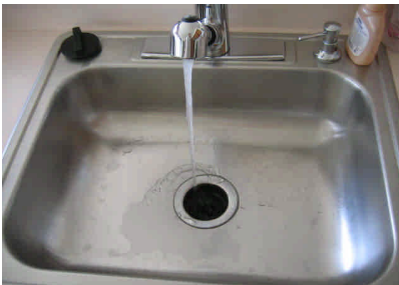
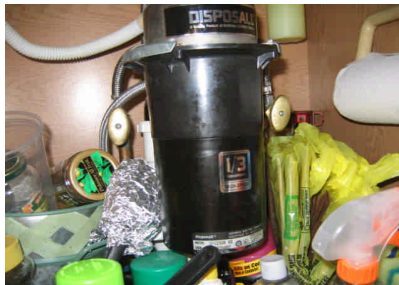
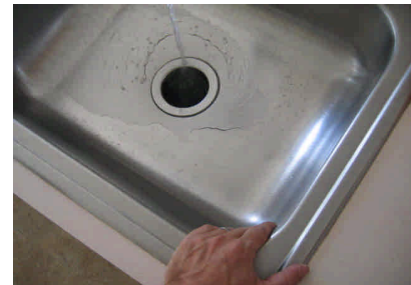
Faucet

The sink faucet is functional. No active leaks seen.
