THE HOME INSPECTION REPORT

21070401 - Client Last Name

123 Main Street, Sample City, NY 12345

07/04/2021 8:00 am - 11:00 am

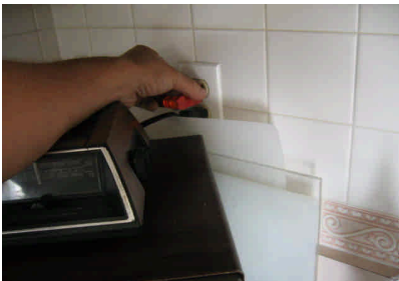
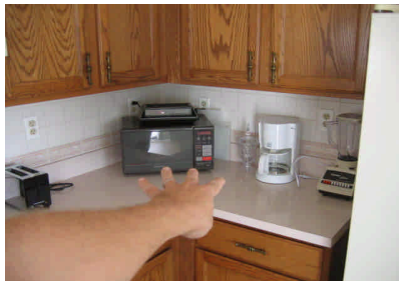
Missing GFCI-protection at the kitchen counter receptacles. All of the countertop and island receptacles should be upgraded to have ground fault GFCI protection, which is mandated by current standards and is an important safety feature. Right of stove.

CORRECTION AND FURTHER EVALUATION RECOMMENDED:

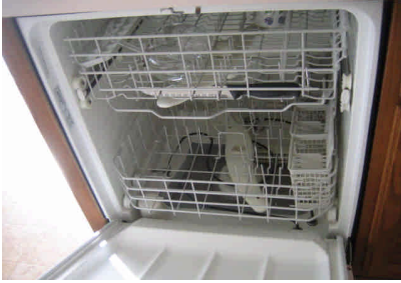
Dishwasher

Ran a short cycle with no leaks. (This is no guarantee against future problems.)

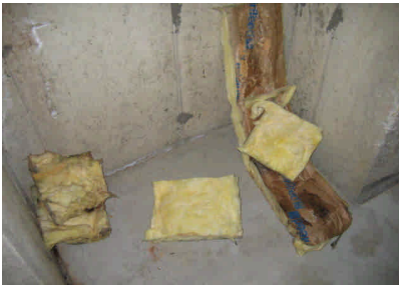
Signs of mold growth is visible in the basement. The mold is in the insulation under the fireplace.

Mold is often associated with excess moisture and can be a problem in indoor environments at high levels. Some molds have the potential to cause health problems. Some molds can produce allergens (substances that can cause allergic reactions), irritants, and in some cases, potentially toxic substances (mycotoxins). Since there is mold growth in the home, the mold must be cleaned up and the water problem must be fixed. If the mold is cleaned up, but the water problem is not fixed, then, most likely, the mold problem will come back. According to the U.S. EPA in their booklet: A Brief Guide to Mold, Moisture, and Your Home, since the moldy area is less than about 10 square feet, in most cases, a home owner can handle the job of cleaning up the mold. If you do not choose to do the mold cleanup, then contacting an indoor air quality professional to assist in the determination of appropriate actions is necessary. The U.S. Environmental Protection Agency has set some mold cleanup guidelines. For more information, visit www.epa.gov/iaq/molds/moldguide.html.

CORRECTION AND FURTHER EVALUATION RECOMMENDED:

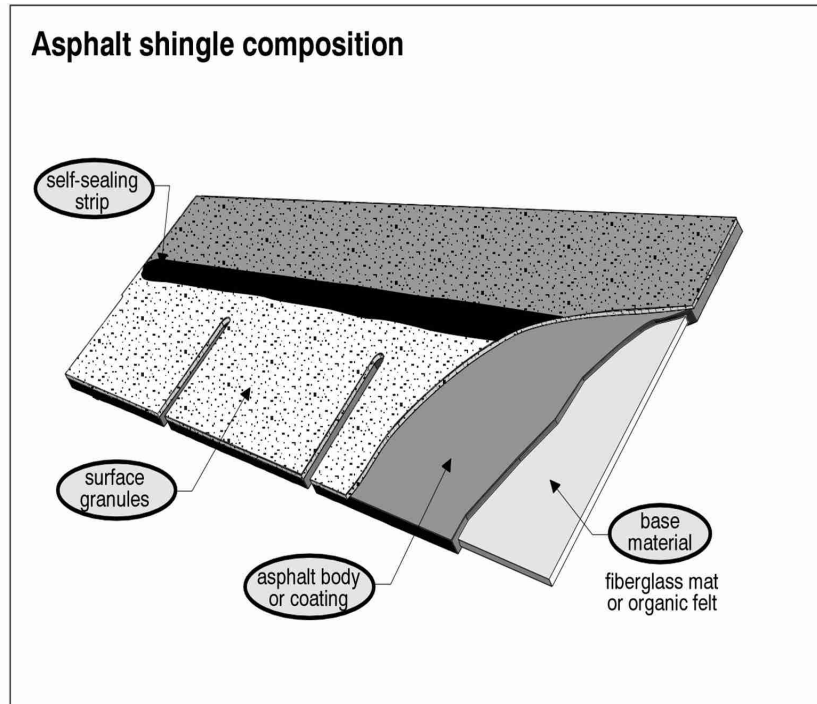
Illustration - 1 Asphalt Shingle Roof Installed - Illustration

The shingles are comprised of asphalt or fiberglass materials impregnated with mineral granules that are designed to deflect the deteriorating ultra-violet rays of the sun. The most common of these roofs are warranted by manufacturers to last from fifteen to twenty-five years. The actual service life of the roof will vary, depending on a number of interrelated factors including the quality of the material and the method of installation. Regular maintenance will certainly extend the life of any roof.

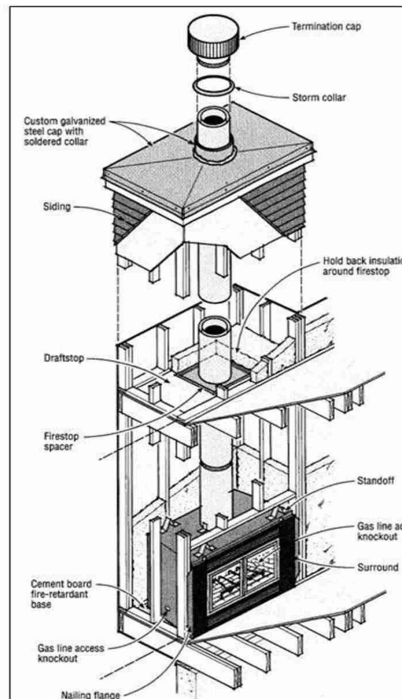
Illustration - 2 Prefabricated Chimney

Factory built pre-fab fireplaces can provide a home with warmth and atmosphere. But, if they are mis-used, they can create problems for a homeowner.

When someone starts interchanging and substituting components, the fireplace may not function the way it did during the stringent testing and manufacturers can no longer guarantee its safety.

Any change made to any component can void the listing and the manufacturer's warranty.

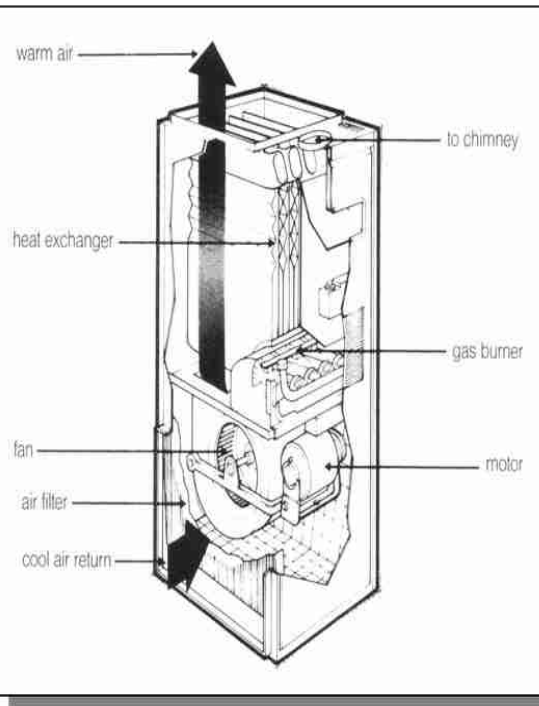
Illustration - 5 Heating system inspected by using normal operating controls

This inspection of the heating system is a visual inspection using only the normal operating controls for the system. The inspection of the heating is general and not technically exhaustive. A detailed evaluation of the interior components of the heating system is beyond the scope of a home inspection. It is essential that any recommendation that we make for service, correction, or repair be scheduled prior to closing or purchasing the property, because the hired-professional could reveal defects or recommend further repairs that could affect your evaluation of the property.

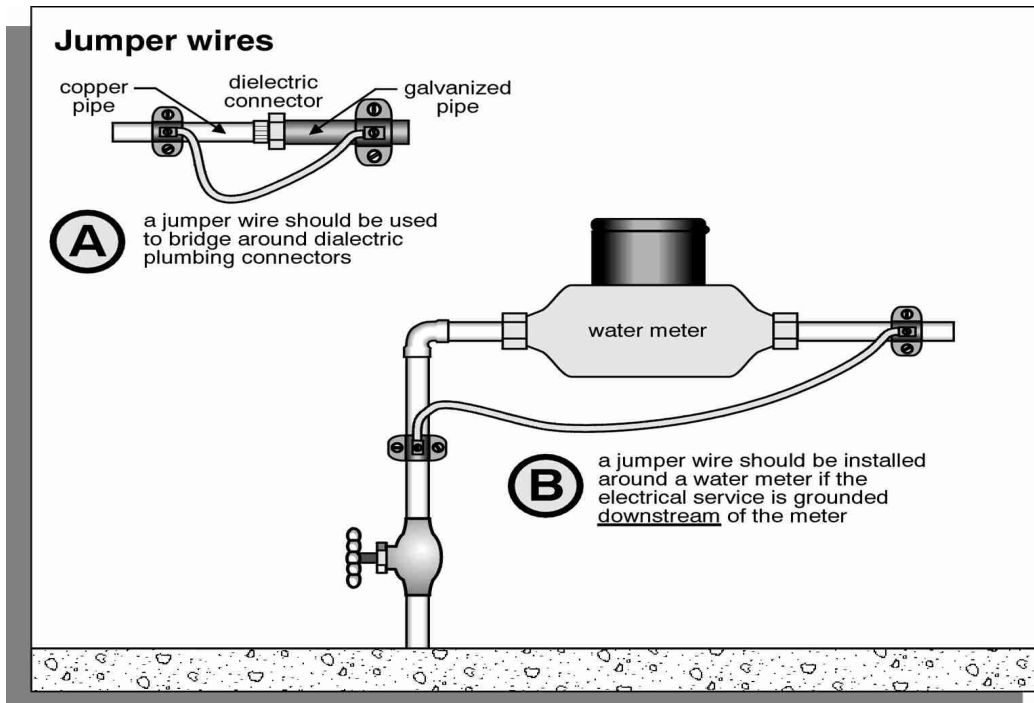
Illustration - 6 Jumper cable installed - Good

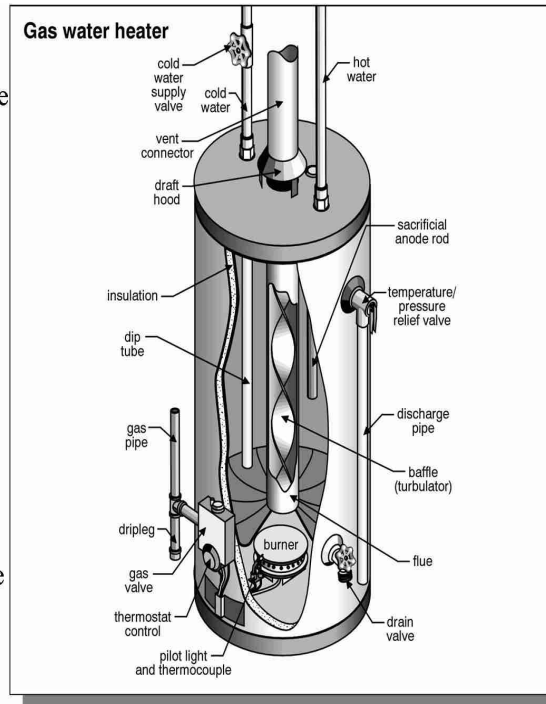
Illustration - 7 For Your Information - Gas Water Heater Tank

There are a wide variety of residential water heaters. They can be expected to last at least as long as their warranty, or from five to eight years, but they will generally last longer. However, few of them last longer than fifteen or twenty years and many eventually leak.

It is wise to have them installed over a drain pan to catch a leaking tank. Also, it is prudent to flush them annually to remove minerals.

The water temperature should be set at a minimum of 110 degrees fahrenheit to kill microbes and a maximum of 140 degrees to prevent scalding.

Water heaters can be dangerous if they are not equipped with a pressure/temperature relief valve and its discharge pipe extended to within 6 inches of the floor.

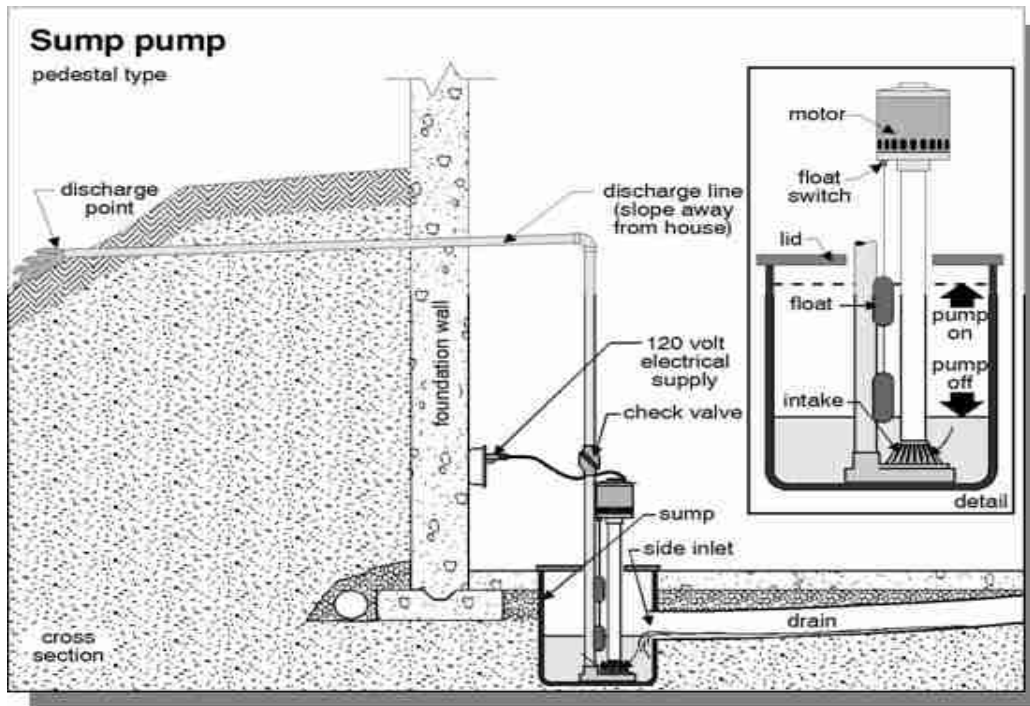
Illustration - 8 A sump pump being used - why

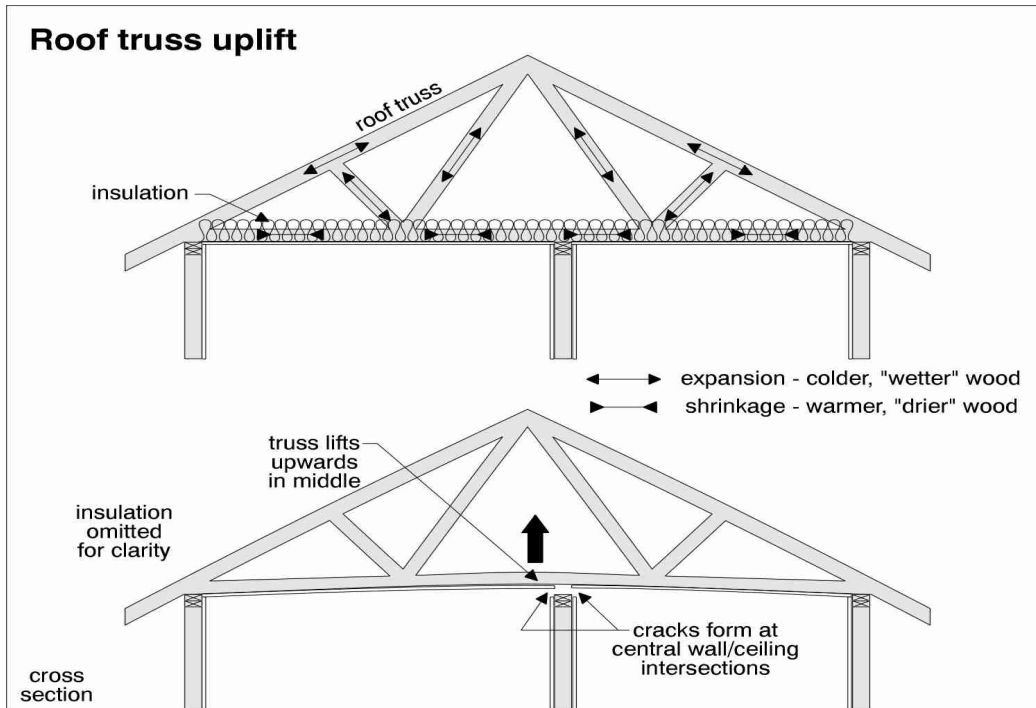
Illustration - 9 Engineered truss
